Performance Testing of American Solar Low Cost Polymer Solar Air Heating Panel

Testing and Reporting by:
Tommy Cleveland
North Carolina Solar Center
Campus Box 7902
North Carolina State University
Raleigh, NC 27695-7902
(919) 515-3716

Equipment Manufacturer:
American Solar, Inc.
8703 Chippendale Court
Annandale, VA 22003
(703) 346-6053

Date
July 28th, 2005

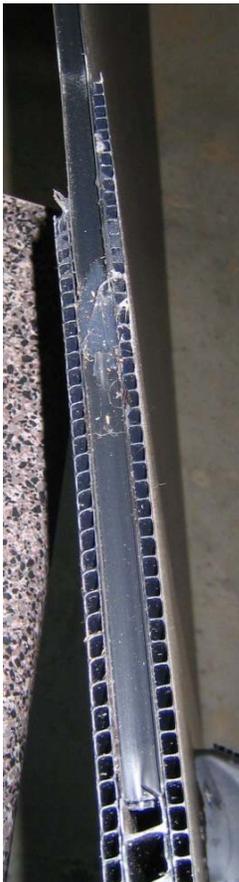
American Solar worked with the North Carolina Solar Center (NCSC) staff to construct three solar air heating collector panels totaling 90 square feet of collecting surface from material supplied by American Solar. Two twinwall fluted panels (TFP) were constructed of primarily two 4' by 8' sheets of 1/2" inch twinwall fluted (corrugated) polymer sheets and smaller twinwall pieces used to create the collecting air plenum in each collector. Some of the construction details of the two identically constructed panels may be seen in the photographs on this page. An outlet duct was attached to each plenum. One of these collectors was outfitted with an array of thermocouples and back-insulated with a 1/4" sheet of white twinwall polymer. Due to budgetary constraints the second twinwall collector was not outfitted with

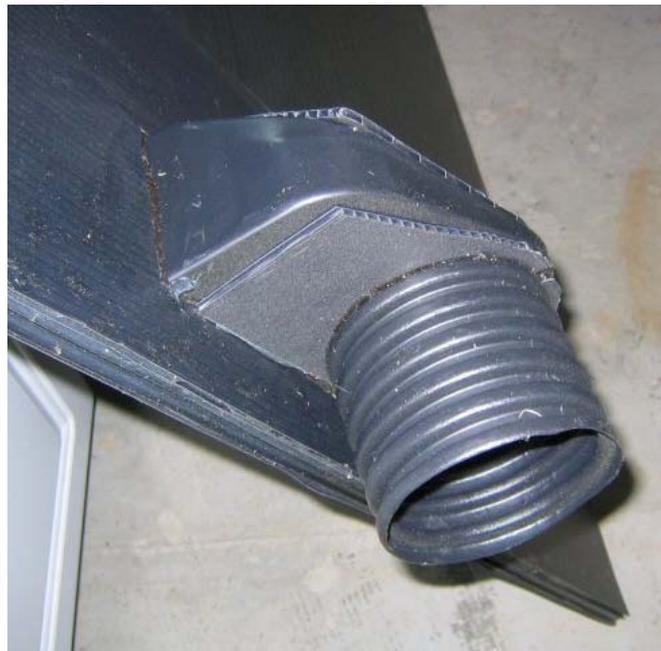
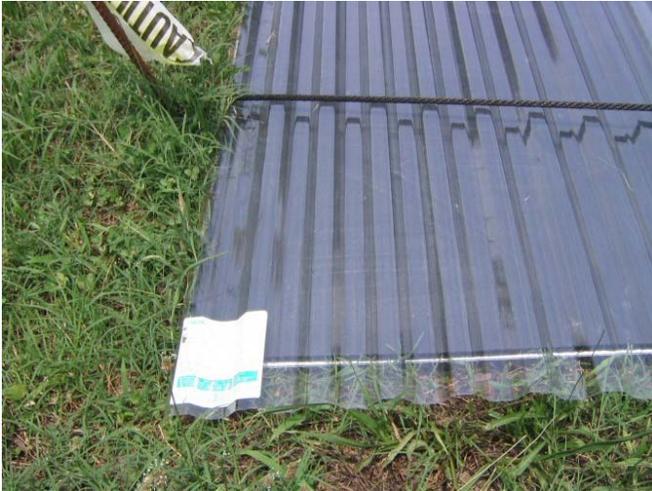
thermocouples, and therefore provided no performance data. In total, approximately 60 square feet of TFP were constructed.

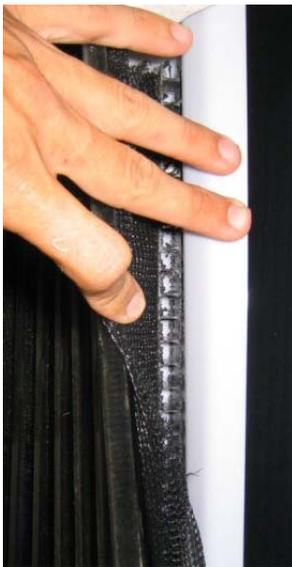
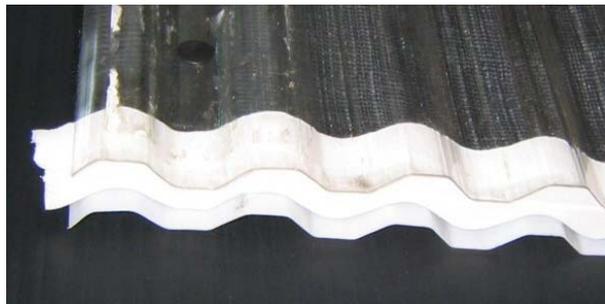
American Solar and NCSC staff constructed two glazed transpired panels (GTP) that did not go through testing. Photos of the glazed transpired panels are shown below displaying the construction of the panels. The panels are basically two layers of corrugated clear polymers with a black shade cloth stretched between the two layers in a manner that would require air passing through the collector to repeatedly pass through the shade cloth, removing the solar energy absorbed by this material. To collect heat from the panels, an air plenum would need to be constructed to allow for controlled collection of solar heated air. Due to NCSC project budget constraints and

a lack of air plenum design or materials these collectors were not performance tested. The two collectors are approximately 32 square feet of GTP.

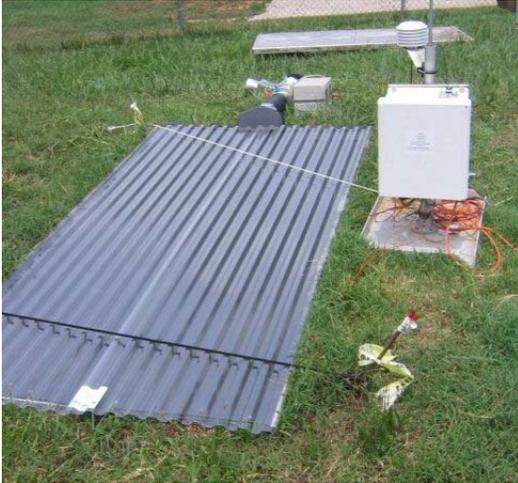
The testing was completed in Raleigh, NC in the Research Annex at The North Carolina Solar Center in the summer of 2005 by NCSC staff. The panel was placed flat on the

ground as shown in the figure below. Re-bar stakes were used as anchor points for the heavy black rope that held the collector flush to the ground. All of the tests were conducted with the American Solar-supplied fan (Dayton 2C647) sucking air through the collector and exhausting the solar heated air from the fan. This allowed for accurate temperature measurements of the solar heated air from before entry (ambient) to collector exit (maximum temperature).

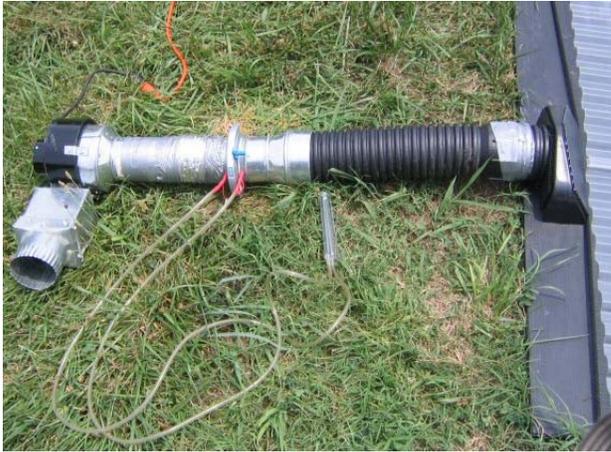
The collector airflow measurements were made using a 4 inch Fantech Iris Damper (IR4) installed between the collector and the fan as shown in the figure below. Two feet of straight duct was provided before the damper and over one foot of straight duct was installed between the damper and the fan inlet. Although the exterior pipe diameter experiences a change less than a foot before the damper, the interior diameter remained constant.

The Iris Damper not only allowed for airflow measurements to be made by measuring the static pressure difference before and after the iris, but it also functioned as a simple and repeatable way to adjust the airflow through the collector. Unfortunately with the large flow resistance of the collector, even large adjustments to the size of the damper opening had only moderate effects on the flow rate through the collector. With the fan connected to the collector and the

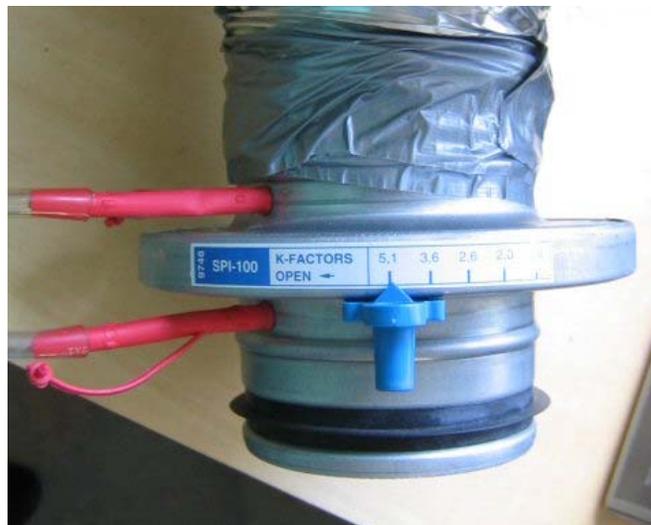
damper set to the largest marked opening setting, a K-factor of 5.1 as seen in the photo below, the flow rate through the collector was 21.5 cubic feet or air per minute (CFM). With the damper set to the smallest marked opening setting, a K-factor of 1.6, the flow rate through the collector was only reduced to 17.8 CFM. When the fan and damper were disconnected from the collector just after the collector exhaust, so that the long straight section of duct before the damper was maintained, the flow rate at a K-factor 5.1 resulted in a flow rate of 97.4 CFM, and a damper setting of 2.0 resulted in a flow rate of 37.5 CFM. Clearly the collector added a significant amount of pressure drop which will have an effect on the amount of fan energy needed to create the desired air flow rate through the collector.

The damper was physically adjustable to greater extremes than the K-factor scale provided, from fully open to nearly closed, but these positions were off of the non-linear K-factor scale so no K-factor was able to be determined for these extreme positions and thus no flow rate could be calculated. In the testing the lowest K-factor used was 2.0 because the only lower factor, 1.6, created a differential pressure of

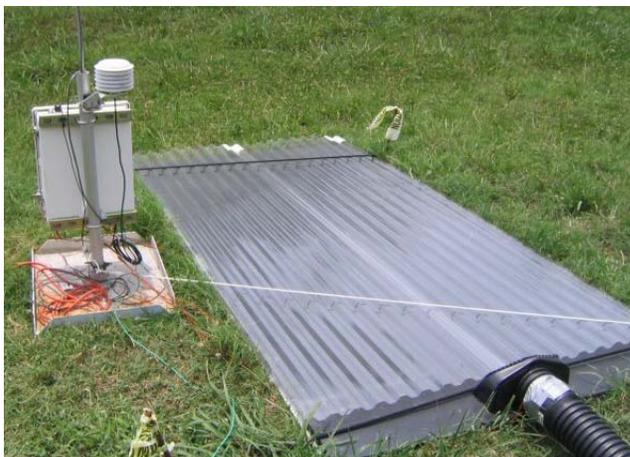
The detailed testing station was based around a CR10X Campbell Scientific Inc. (CSI) datalogger in a ground mounted weather tight box. The collector testing setup, including a view of the weather tight box containing the datalogger may be seen in the photo below. The datalogging system was constructed by NCSC staff from equipment they previously owned. The station allowed for real-time data collection of global horizontal radiation via a LiCor pyranometer, wind speed at approximately 4 feet above the ground via a NRG Hall Effect anemometer, ambient temperature and relative humidity via a CSI shielded probe, and the many air temperature readings in the collector via small hand-mounted type-T thermocouples. The reference temperature for the thermocouples was obtained by a CSI thermistor mounted near the surface of the datalogger. All of these measurement devices are of research caliber and are expected to provide accurate readings.

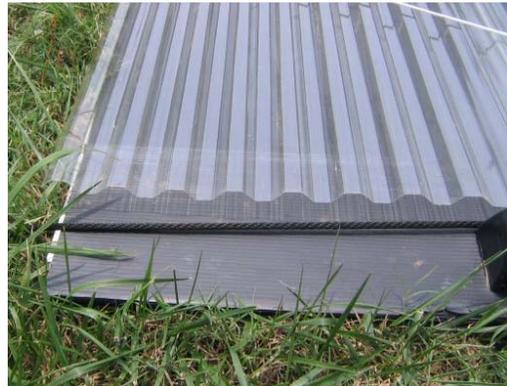
The collector was tested with the addition of simple corrugated glazing. The glazing was not adhered to the collector surface, just simply laid flat on the collector and secured under ropes tied between the collector stakes. As can be seen in the photograph below there was limited effort made to seal along the edges of the glazings. In places this resulted in up to 1 inch gaps between the glazing and the edge of the collector. The potential gain from a tighter

union of the collector and the glazing is not known.

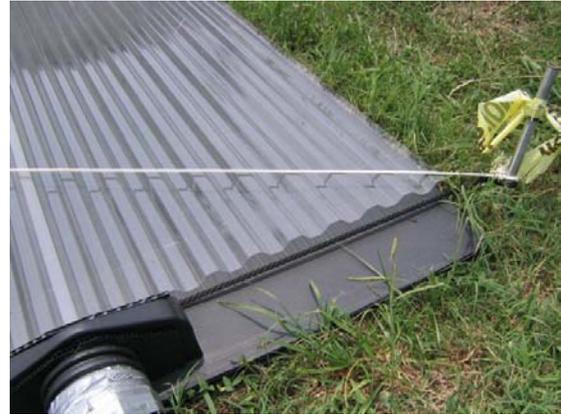
Temperature Rise: 74.3 °F was the maximum temperature rise seen. This occurred when the collector experienced sustained incident solar radiation of 850 W/m² for over 10 minutes. A higher temperature rise (78°) was seen during preliminary testing at a higher, but unmeasured, air flow rate.
